Chapter 9

Did the DE brace brake off first - before the D6 brace?

The DE brace

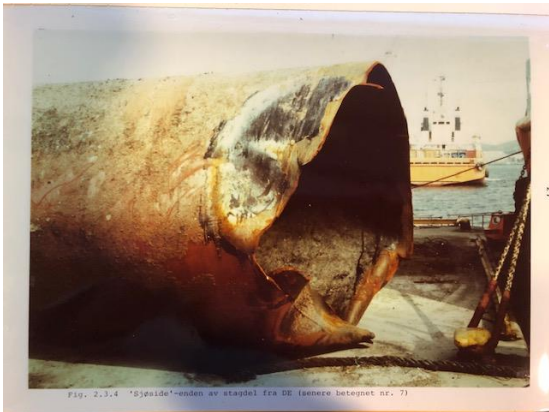
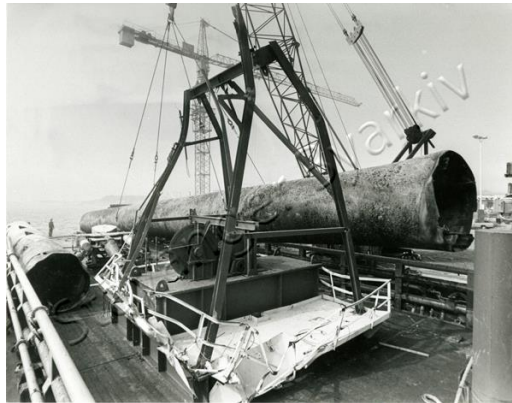
By studying the shape of the fracture surfaces on both sides of the DE brace there are elements that may indicate that the fracture took place ahead of the fracture in the D6 brace. After the breach near the E leg, the brace may have been bent down to the top of the pontoon of the E leg - and may have been in this position for some time. By studying the paint on the outer part of the brace it may seem that this theory has something to it. The DE brace was the longest and heaviest brace that was connected to the D leg, which broke off the rig on 27 March. The DE brace was one of two horizontal underwater braces attached to the torn-off D leg, it was 40 meters long and 60 tons heavy, and was welded to the D and E legs.

Jim Rune Pettersen does not attach importance to the anchoring. He believes that the main cause of the breach in the DE brace was a welding fault in the brace near the E leg. Both assess the fracture surfaces on part 8 (closest to the E leg) as a pure tensile fracture with smooth surfaces. In a report from the Norwegian Institute of Naval Research dated 30 July 1980 it is stated:

*"The break in part 8 was very likely a pure tensile break. The initiation point for the fracture may have been approximately position 510 or approximately position 720 in/at the weld between the internal struts and brace."*¹³³

If the brace broke off completely near the E leg in advance of the accident, the brace would have been stopped by the large pontoon on which the E leg rested. The wave forces would cause the end of the brace to be ground against the pontoon. This corresponds to pictures of the brace.
